INDIA Qutb Minar and its Monuments, New Delhi

II.1 Introduction

State of Conservation of the World Heritage Properties in the Asia-Pacific Region

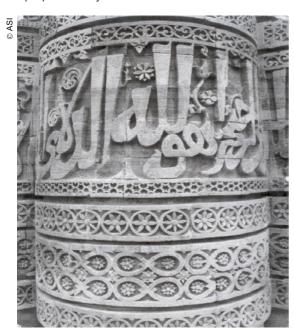
Flutings, floral band, after restoration
